A Case Study of Ground-Penetrating Radar for Concrete Moisture Mapping and Void Detection in the Saturated Soil Beneath the Concrete Residential Foundation, Houston

By *Mustafa Saribudak*, Environmental Geophysics Associates

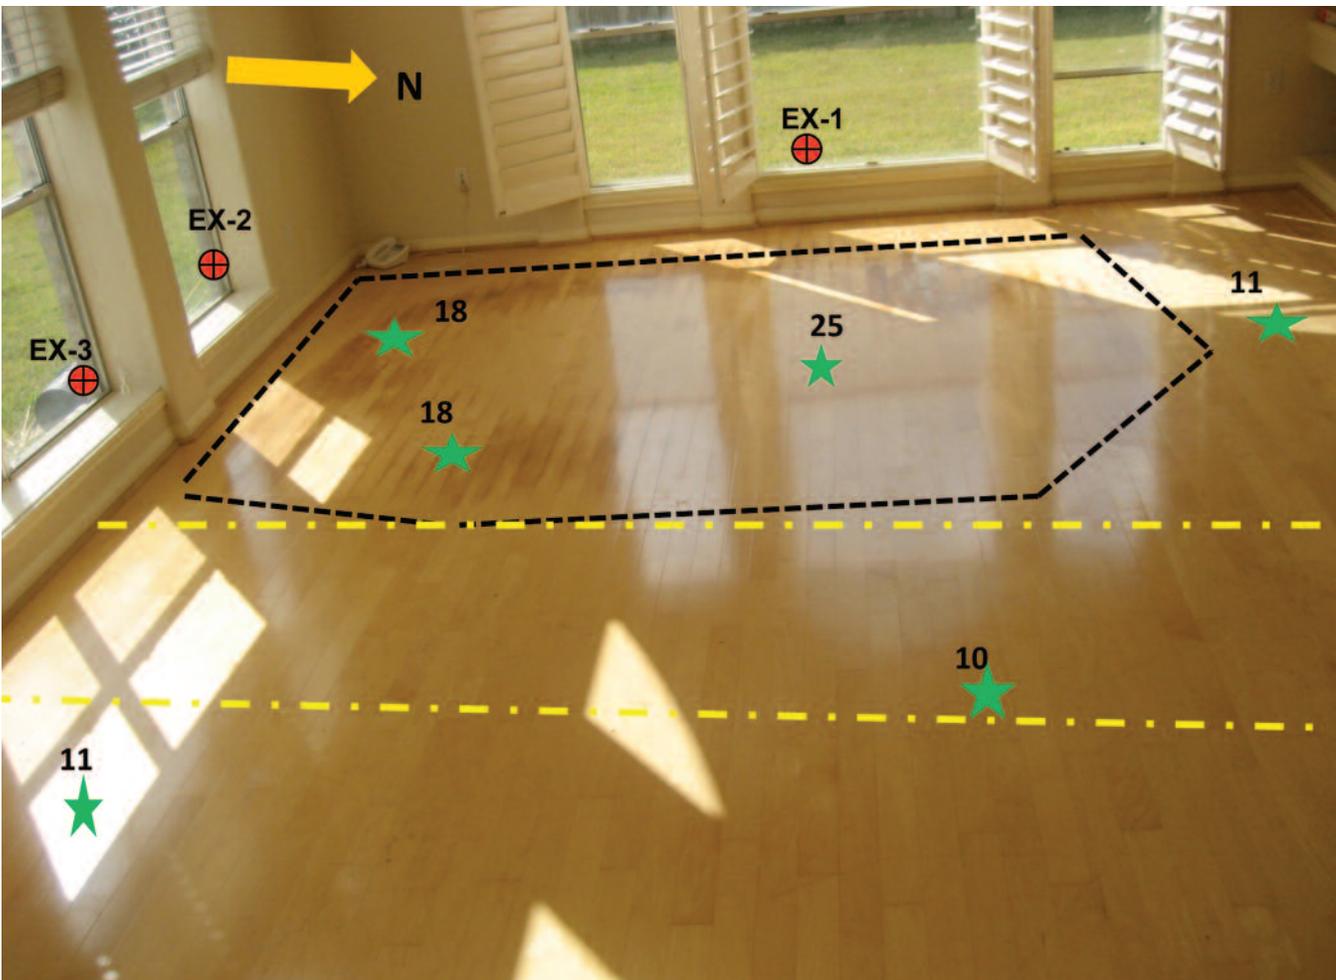
Figure 1. GPR study area showing the discolored portion of the wood floor with dashed black lines. Location of moisture readings are shown with green stars. Moisture readings 10 and 11 are background whereas 18 and 25 are high moisture areas. Dashed yellow lines show two post tension cables embedded into the concrete at about 3 inch. Red circles are excavation points.

The subject residence is located in the northwest part of Houston, Texas. The house is eight years old. The homeowner replaced the carpets in the living room with wood one year after they moved in. The wood floor started showing discoloring within three months right after it was installed (Figure 1).

readings and values are shown in Figure 1. An engineering company was contracted to evaluate the moisture problem in the living room. However, results from the plumbing and engineering studies neither pinpoint the source of the moisture specifically nor the conditions of the concrete slab and the soil beneath it. To address the problem, the homeowner hired his own geophysical company to perform ground-penetrating radar surveys in the living room.

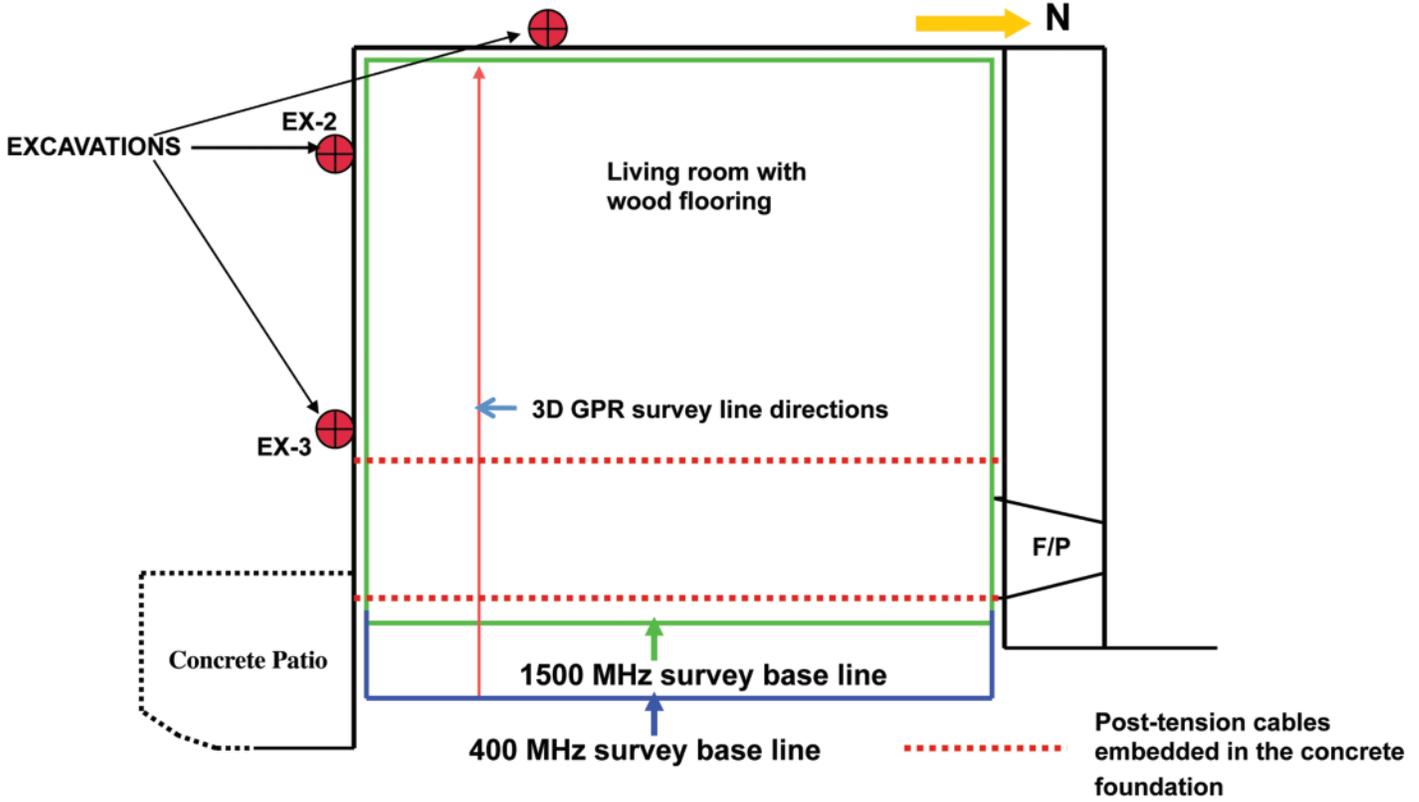
Figure 2. Schematic site map showing 3D GPR survey design.

A GSSI SIR-2000 GPR system was used during the surveys with antennas of 1500 and 400 MHz, whose ranges have depth penetration of up to 1 foot and 8 feet, respectively, depending on the conductivity of the concrete slab and the underlying soil. A schematic map of the living room is shown in Figure 2.

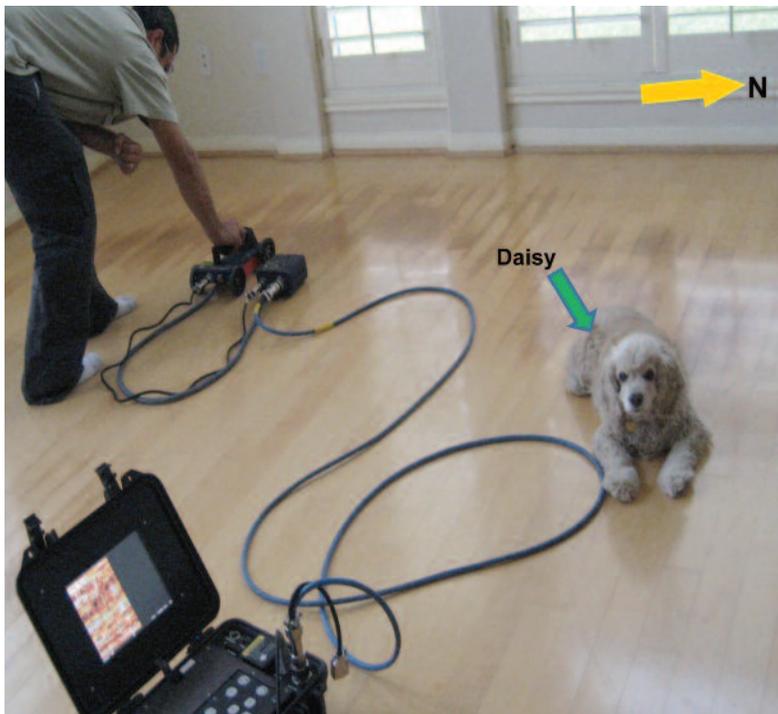
Figure 3. Picture showing the 1500 MHz GPR survey in the living room. The GPR data was collected at every 6 inch.

The 1500-MHz antenna was used with a hand-held cart system to collect three-dimensional (3D) GPR data (Figure 3). 26 profiles of GPR data with six (6) inch spacing were collected.

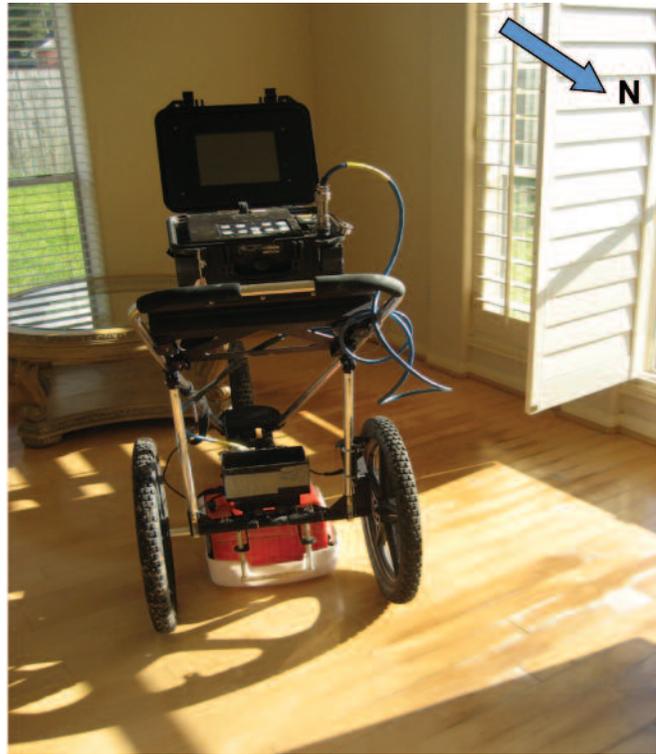
Figure 4. Picture showing the 400 MHz GPR survey in the living room. The GPR data was collected at every one foot.

The 400-MHz antenna was used with a cart system to collect 3D GPR data (Figure 4). 15 profiles of GPR data with one (1)-foot spacing were collected. It should be noted that this survey's baseline ($X = 0, Y = 0$) starts 3 feet to the east of the 1500 MHz surveys.

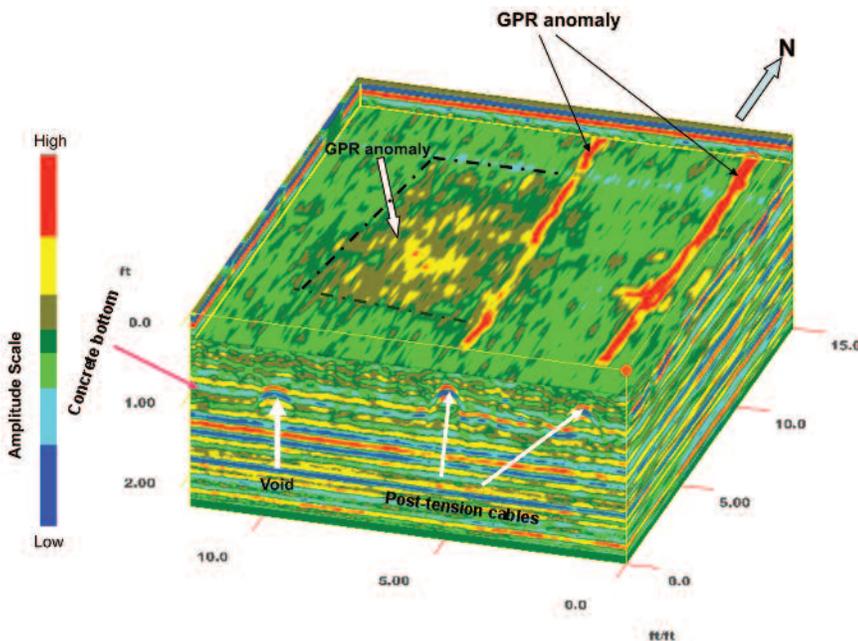
Figure 5. 3D GPR data for 1500 MHz survey showing a depth-slice view at 3 inch into the concrete foundation.

The 3D GPR results for the 1500-MHz surveys are given in Figure 5, which shows a 3-inch depth-slice view of the entire study area. The map view displays two significant linear GPR anomalies shown with red and yellow colors. These anomalies trend in the north-south direction and are labeled as PTC-1 and PTC-2, whose sources are caused by ferrous materials within the concrete. In fact, a 3/4-inch post-tension cable was observed on the concrete foundation outside the study area. PTC-1 anomaly appears to lose its high-amplitude strength in the

middle of the study area. In other words, the integrity of the post-tension cable appears to be compromised. A very significant anomaly is also shown with light brown and yellow colors to the

west of PTC-1 anomaly. This anomaly is outlined with a dashed-black line on the map (top) view of Figure 5. The geometry of this anomaly is quite correlative with the observed moisture-affected areas of the wood floor (see Figures 1 and 5). A void anomaly immediately beneath the concrete slab is also located in the 2-D section of Figure 5.

- Two post-tension cables were located, which were embedded in the concrete at a depth of 3 inches;
- One of the post-tension cables did not have as strong an amplitude anomaly as the other. This may indicate that the integrity of the former PTC is somewhat compromised;
- A low-to-moderate amplitude anomaly is observed to the west of the compromised PTC. The shape of this anomaly is quite correlative with the discolored, moisture-affected areas of the wood floor. This correlation suggests that the cause for the anomaly could be the moisture leaks through the concrete foundation from the disintegrated PTC (see Figure 5);
- A void was also detected at the bottom of the concrete foundation.

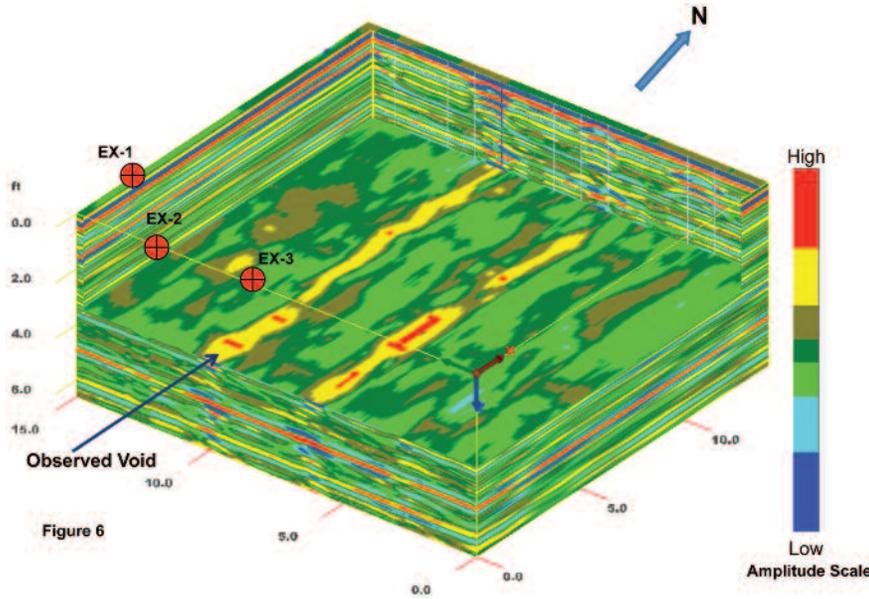
Figure 6. 3D GPR data for 400 MHz survey showing a depth-slice view at 2.5 feet. EX-1, 2 and 3 are excavation locations along the foundation.

The 3D GPR results for the 400-MHz surveys are given in Figure 6, which shows a 2.5-foot depth-slice (top view) of the entire study area. The map view displays two linear moderate-to-high amplitude anomalies in north-south directions. The majority of these anomalies are shown with the yellow color, which is caused by dielectric contrast (low dielectric vs. high dielectric values) within the soil underlying the concrete foundation. The sources of these anomalies are not known, but they could be caused by voids partly filled in part with water. However, there are high-amplitude zones (red color) within the anomalies shown with the yellow color. The red areas are probably caused by voids filled with air. It should be noted that two linear anomalous features are located approximately beneath the post-tension

cables embedded within the concrete. This correlation between the linear anomalies in the soil and the location of linear PTC anomalies within the concrete is either coincidental or they are somehow related. A deeper 4-foot depth-slice does not indicate the presence of the two linear GPR anomalies or any other significant subsurface targets within the soil underlying the concrete foundation (Figure 7).

- Two linear GPR anomalies were detected at a depth of 2.5 feet from the surface of the concrete foundation. These anomalies

are mostly moderate in amplitude. However, they show areas of high amplitude as well. These anomalies trend in the north-south direction, and are located approximately beneath the PTCs;

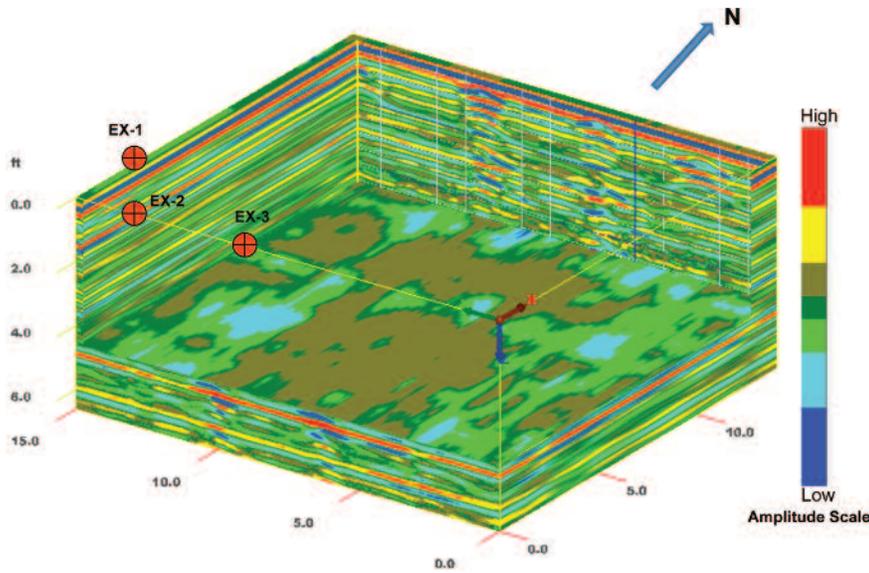
Figure 7. 3D GPR data for 400 MHz survey showing a depth-slice view at 4 feet.

- The GPR data do not show any significant anomaly at a depth of 4 feet;
- Three locations (EX-1, EX-2, and EX-3) were excavated along the foundation outside the living room. The EX-1 and EX2 locations did not reveal any wet soil or water, as expected, because there were no GPR anomalies beneath the concrete foundation; however, the EX-3 excavation was chosen to be next to one of the linear GPR anomalies, and it did show a significant void beneath the foundation. The other linear anomaly was not tested because the location was covered with a concrete patio.

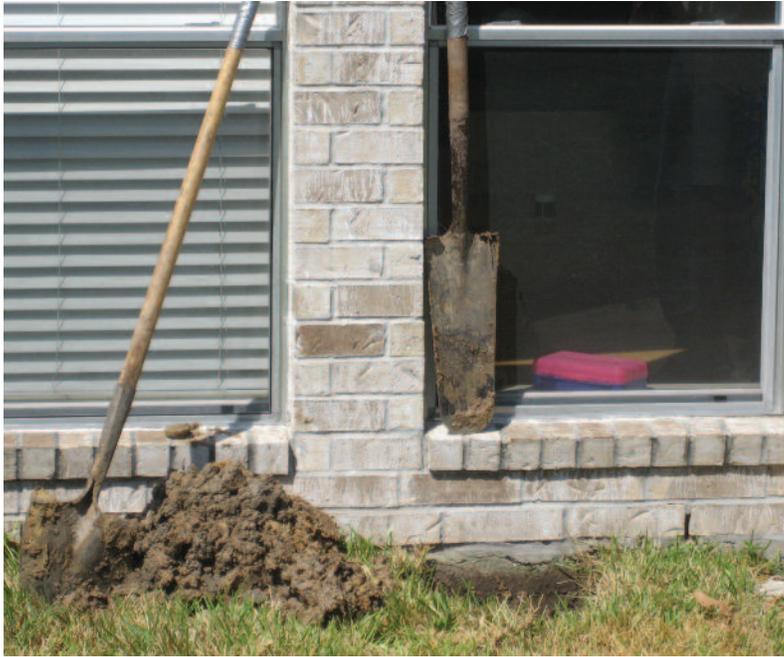
Figure 8. Picture showing the EX-3 excavation in the south wall of the foundation.

Three locations (EX-1, EX-2 and EX-3) were excavated next to the foundation on October 8, 2008. These locations are along the foundation next to the southern and western walls of the living room (see Figures 1, 2 and 6) The EX-1 and EX-2 locations did not reveal any void or wet zone beneath the foundation; however, the EX-3 location revealed a void beneath the foundation (Figure

Visual inspection of the surface conditions next to the foundation in the vicinity of the void indicated ponding conditions, which may have resulted over the years, in saturated soil conditions along the faulted foundation and the water being forced under the slab through a created void.

A French Drainage system was installed along the foundation in order to decrease the saturated soil conditions, and the wood floor was replaced with ceramic tile. ■

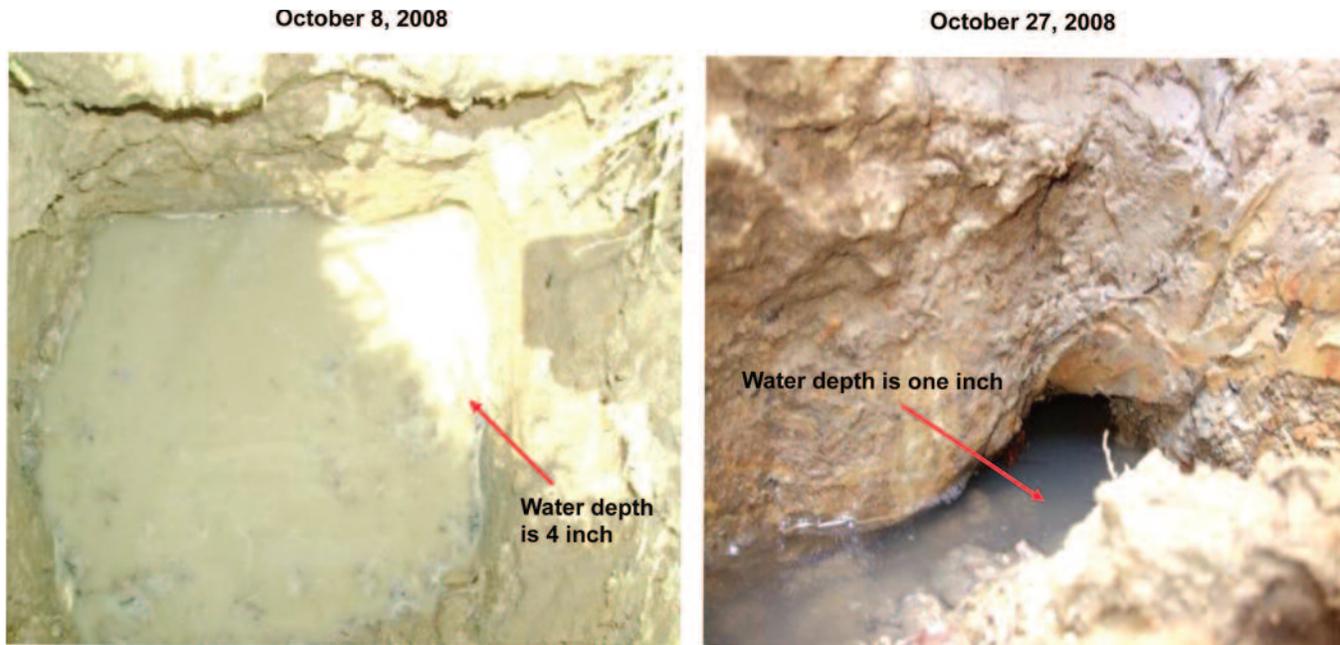
Figure 9. The void in the soil underlying the foundation at EX-3 location. Pictures are taken in October 8 and 27, 2008, respectively. Decrease in water height could be tied up to local monthly precipitation (see Figure 10). The top of the void is about 2 feet below the concrete pad. The material above the soil appears to be hardened clay or grade materials.

8). As soon as a 2.5 foot depth was reached, the excavation hole filled with ground water flowing from the soil underlying the foundation. The height of the water reached to 4 inches on October 8, 2008. A 3-foot-long stick was pushed into the void with little resistance from the soil. This observation correlates well with the presence of the high-amplitude GPR void anomaly at EX-3 location. The hole was filled with dirt and covered, and the location was visited back on October 27, 2008. The water height in the hole reached to one inch on this visit (Figure 9).

The fluctuations of the water height beneath the foundation could be explained by the local monthly precipitation (Houston: Bush Intercontinental Airport Precipitation Data, 2008) which is

located near the subject residence (Figure 10). According to these data, the area received 12.07-inches of rain during the month of September (Hurricane Ike visited Houston on September 12, 2008). The water height on the excavation measured about 4 inches on October 8, 2008. The area received 8.67 inches of rain during the month of October. The water height on the excavation was about one inch on October 27, 2008.
